RE: Site Inspection, United Stone and Design, United Stone #1 Mine, S/047/074, Uintah County, Utah

Date of Inspection: November 14, 2002
Time of Inspection: 12:00 to 1:30 p.m.
Conditions: Mostly sunny, 40's
Participants: Paul Baker, DOGM

S/047/074, United Stone #1 Mine, United Stone and Design

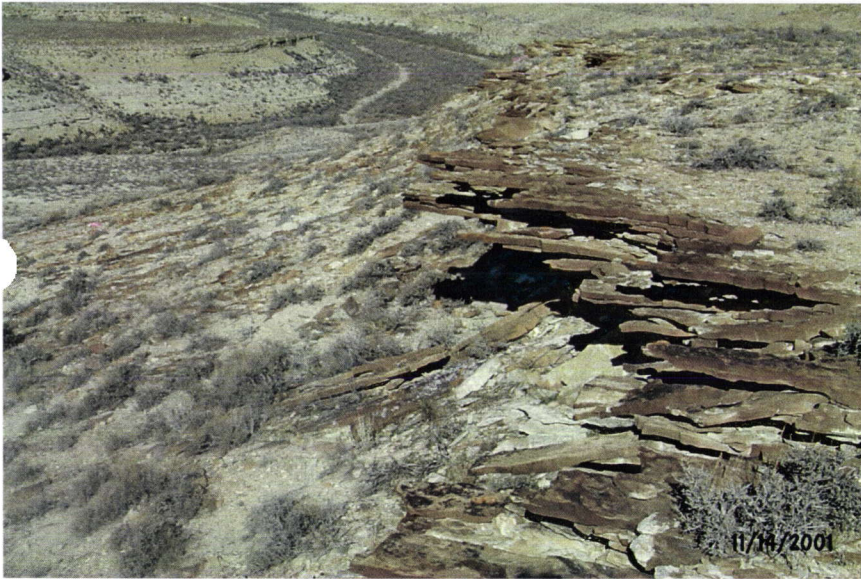
I could not tell that there had been any disturbance from mining. The operator intends to gather stone from the surface, and it appeared there were two strata with material durable enough for building stone. The uppermost of these is shown in Photo 1 and is likely the stone to be mined.

Photo 1. Stone outcrop at the plateau rim.

The stone on the upper level would need to be accessed from the top of the plateau rather than through Agency Draw. I could not see roads that were close to this area, but the operator assured me in a subsequent telephone call that there are existing roads in this area.

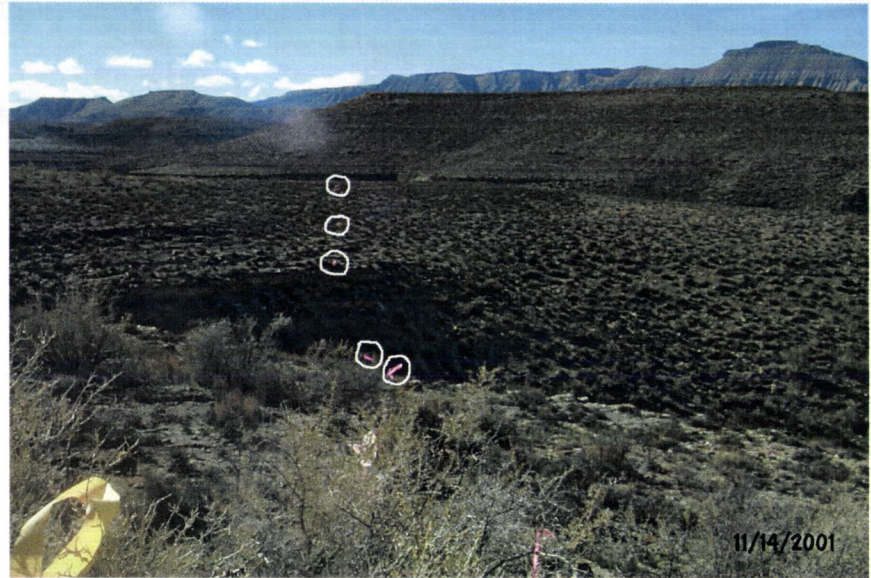
I found a row of pink flags running approximately northeast/southwest through the area (Photo 2), and although I originally thought it might be the boundary of the operator's lease with SITLA, I do not believe that is correct. The flags probably have nothing to do with the mine operation.

Photo 2. A row of flagging running approximately northeast/southwest through the lease area.
